Seagrape Condominium Association, Inc

Milestone Structural Inspection

5160 Las Verdes Circle, Delray Beach, FL 33484

September 16, 2024

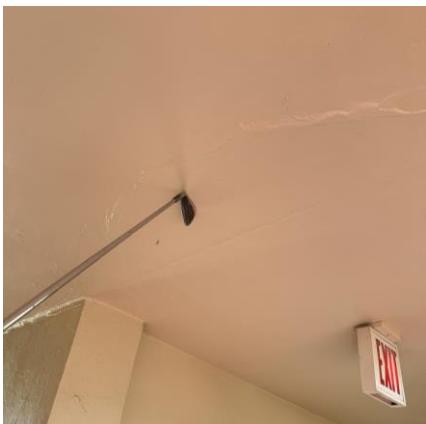
Falcon found the concrete elements to be in good condition with minor localized deficiencies throughout the catwalks, balconies, and slabs. Signs of cracks, concrete void, improper repair of slabs, and deteriorated slab edges were found, which must be addressed to avoid deterioration of the structural elements. (**Exhibit A**).

Photo # 1 Spalled Concrete

- i. Repair of concrete defects on the catwalks and balconies. All detached concrete must be removed before proper repairs can be completed.
 - ii. Repair all deficient areas on the roof, including improper installation, and areas of water ponding, to prevent further deterioration, thus ensuring structural integrity.

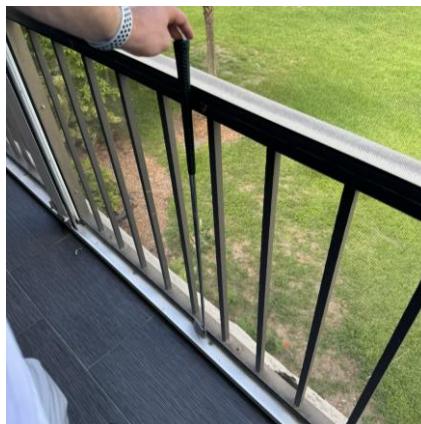
Photo # 2 Void Concrete Slab (Unit 318)

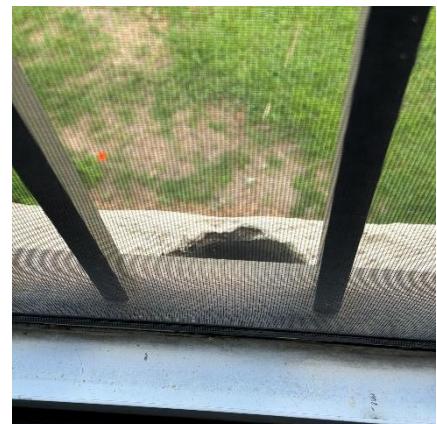
Photo # 3 Close up of Previous Photo

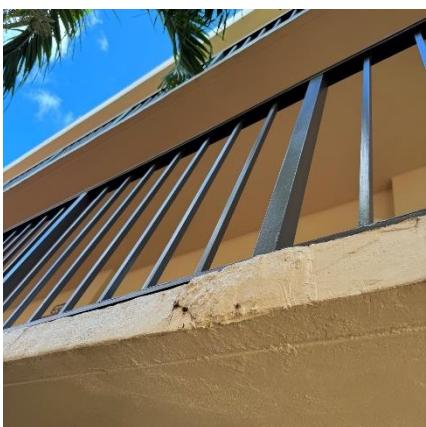
Photo # 4 Spalled Stucco/Concrete

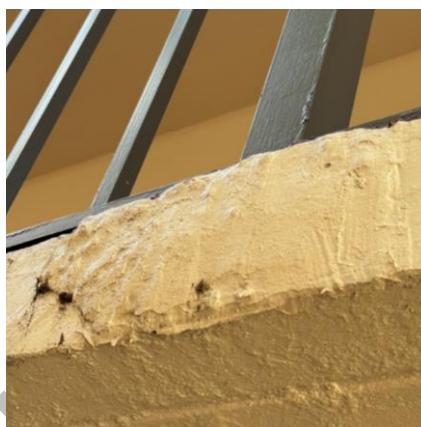
Photo # 5 Close up of Previous Photo

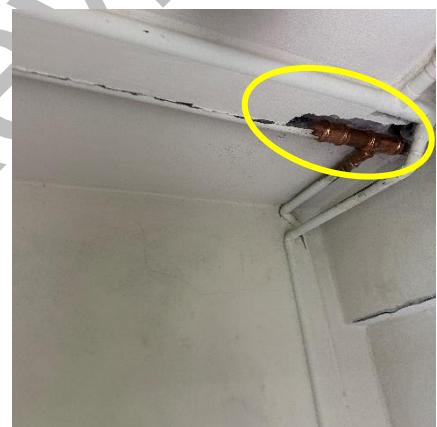
Photo # 6 Improper Slab Cut for Pipe Installation.

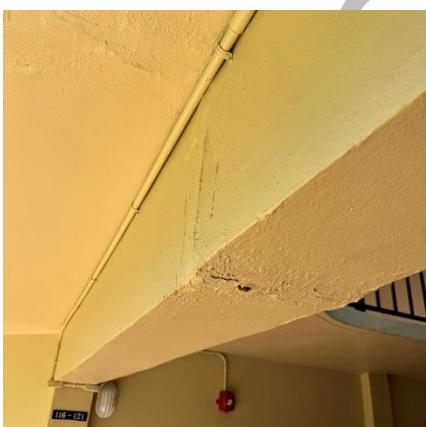
Photo # 7 Deteriorating Expansion Joint

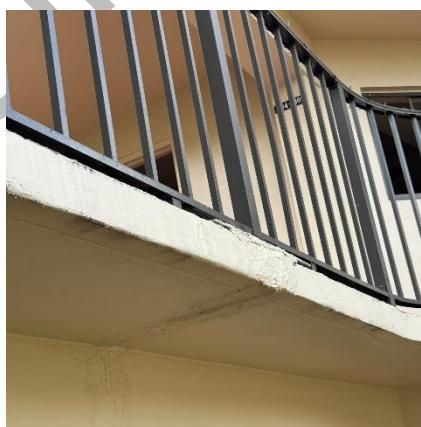
Photo # 8 Deteriorating Expansion Joint

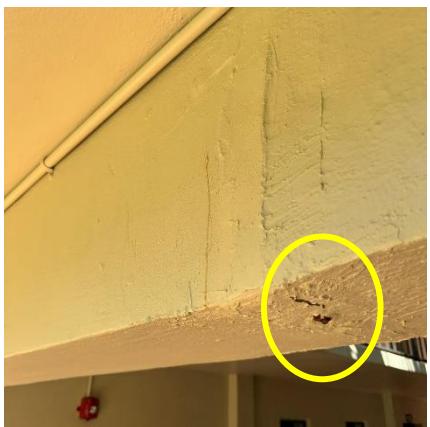
Falcon noted no major signs of rusting throughout the building, corroded embedded metals were observed. However, all observed nails, rust spots, or ferrous materials should be removed and resulting voids properly patched.

Photo # 9 Corroded Rebar Pop Out

- iv. Repair/replace all deteriorated railing elements including post pockets and remove biological growth as well.
 - v. Removal of rust spots and repair of exposed and corroded structural metals. Corrosion of reinforcing steel and other embedded metals in concrete is the leading cause of concrete deterioration and must be addressed to prevent further damage.

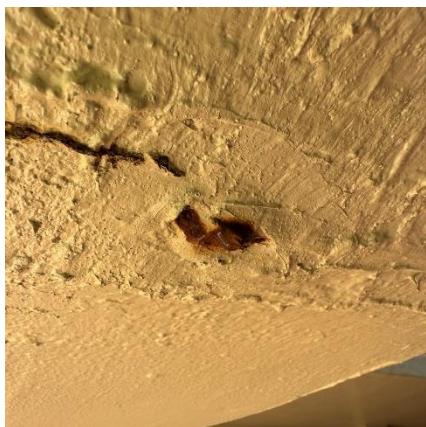
Photo # 10 Close up of Previous Photo

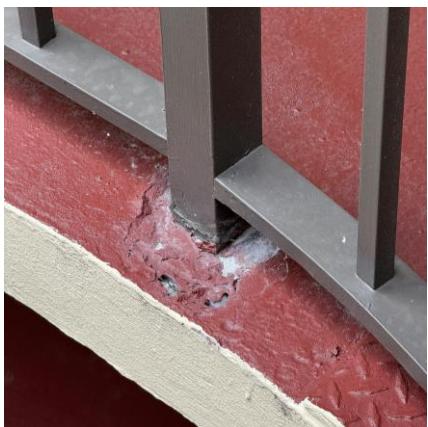
Falcon noted minor signs of deterioration evidenced in deteriorated post pockets, biological growth and loose railing elements. **See Exhibit C**

Photo # 11 Deteriorated Railing Post Pocket

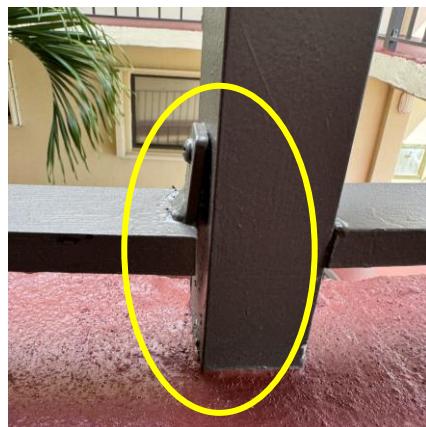
Photo # 12 Deteriorated Railing Bracket

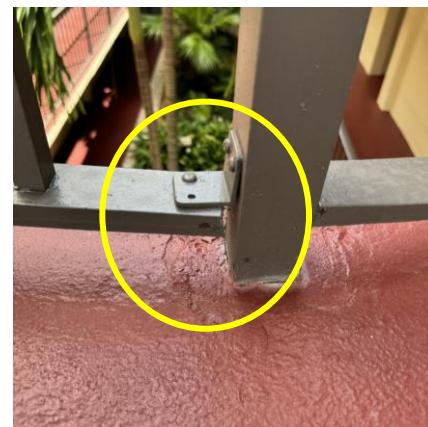
Photo # 13 Missing Fasteners on Railing Bracket

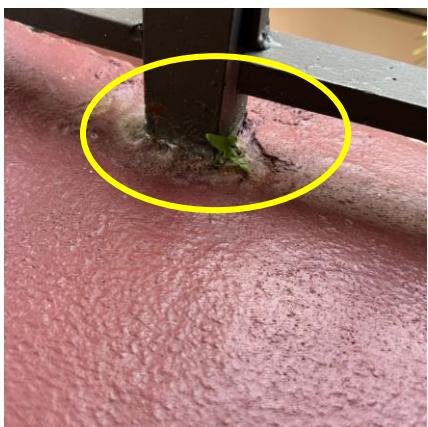
Photo # 14 Biological Growth

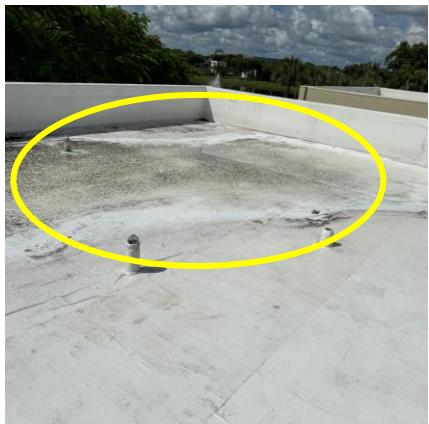
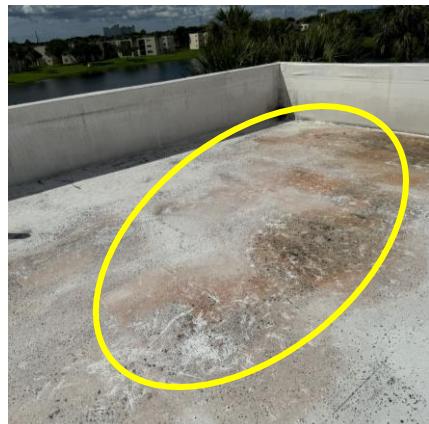
The building's roof is a low slope roofing system and appears to be a TPO Roof Membrane system. The roofing system is in good condition; however, various signs of deterioration was observed including water ponding due to poor slope and improper waterproofing application as well. (**Exhibit D**).

Photo # 15 Signs of Water Ponding

Photo # 16 Signs of Water Ponding

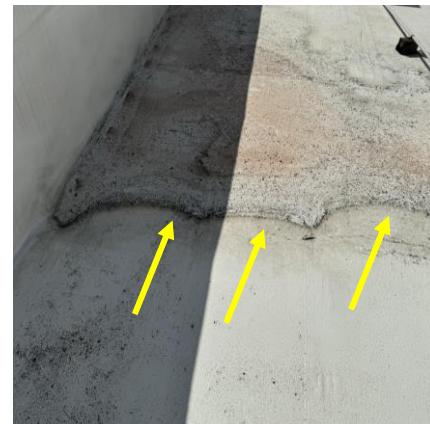
Photo # 17 Improper Waterproofing Application
